MEDUSA

WATERPROOFING

SANDUSKY PORTLAND
CEMENT COMPANY
SANDUSKY, OHIO, U.S.A.

Medusa Waterproofing

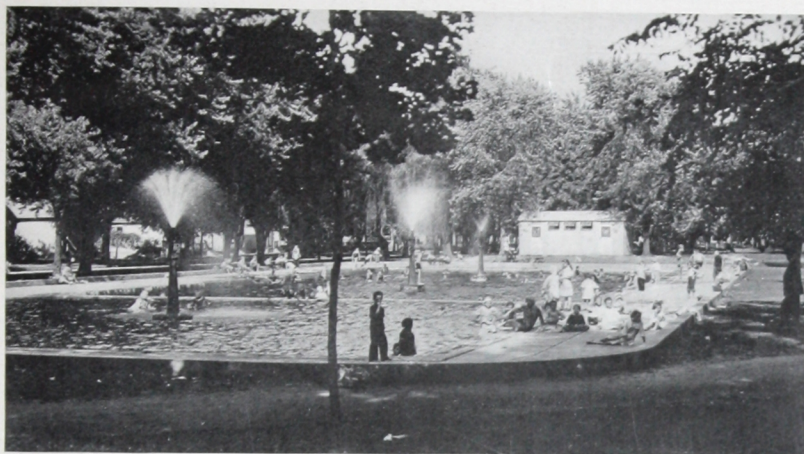
City Park Municipal Bathing Pool, Toledo, Ohio

The swimming pool in City Park, Toledo, Ohio, is 180 feet by 60, and from one to four feet deep, containing two basins, and is surrounded by a walk 12 feet wide. Similar bathing pools are located in Navarre and Riverside parks.

These pools were designed by F. E. Wirebaugh, Engineer for The Board of Park Commissioners, and Schillinger Bros. Company, Toledo, were the contractors. Medusa Waterproofing was used in walls and floors. The pools were completed three years ago and are in excellent condition and no leaks have developed,—more conclusive evidence of the wonderful waterproofing qualities of Medusa Waterproofing, which is being used extensively in other public work in Toledo.

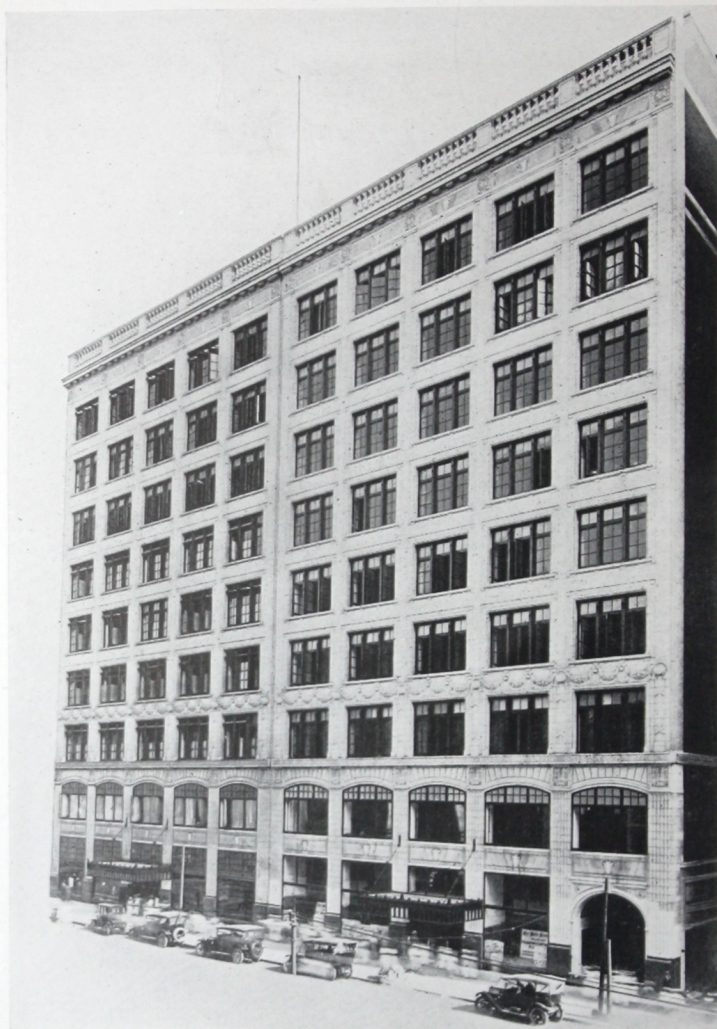
Pope-Whittemore Building and Addition, Cleveland, Ohio.

This building which is occupied by Halle Bros. is of concrete construction, and was designed by Henry Bacon, of New York City.

Water tightness was finally accomplished through the expert workmanship of the contractors, who incorporated 2 per cent. of Medusa Waterproofing to the weight of cement in all sub-basement foundation walls, concrete base and cement topping of basement floors. A 1-2-4 mix was used for all aggregate concrete, and a 1 to 2 mix for floor topping which required an admixture of Medusa Waterproofing totaling 18,000 pounds.

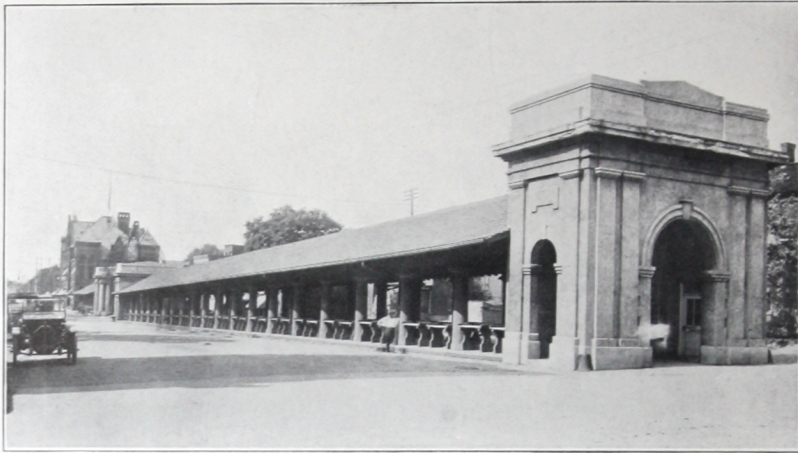
Market Place, Ft. Wayne, Indiana

The Fort Wayne, Ind., market house is constructed entirely of concrete except roof, is 450 feet long and 26 feet 8 inches wide. The walls of the pavilions were built upon a core of brick work, presenting an unbroken surface of concrete made of white sand and Medusa White Portland Cement, with an aggregate of birdseye or roofing gravel. The roof consists of a framework of wood covered with red roofing tile. A concrete floor is provided for the entire structure.

Medusa Waterproofing was used in all of the concrete to the extent of about  $1\frac{1}{2}$  or 2 per cent. of the amount of cement used. Mahurin & Mahurin were the architects, and Borkenstein & Son, the contractors.

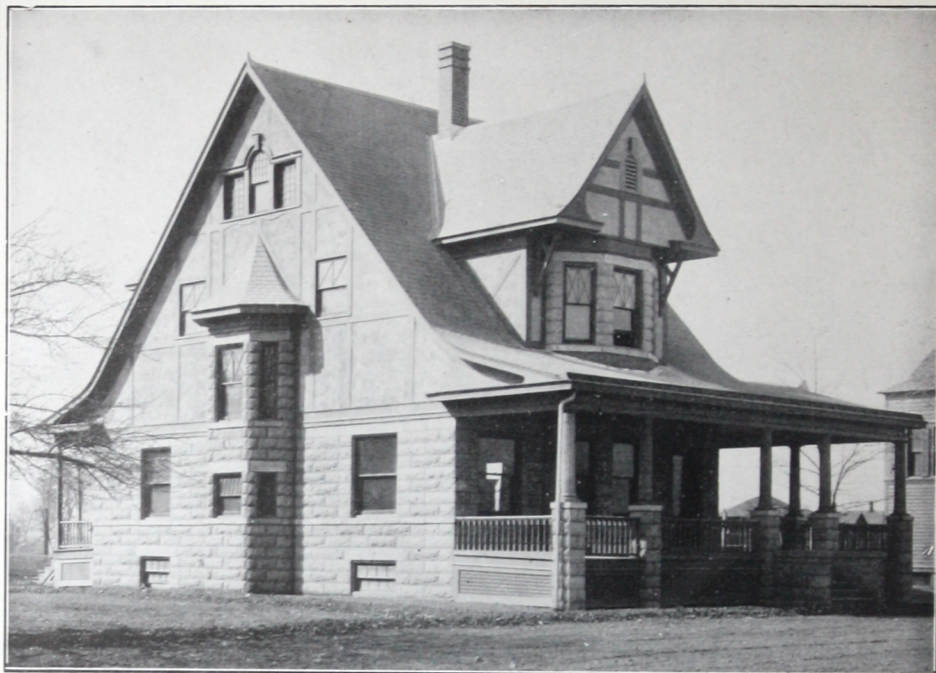
President's House, Sandusky Portland Cement Company, Bay Bridge, Ohio

Only 1 per cent. of Medusa Waterproofing was used in cement for blocks in this residence,—4 pounds to each barrel of cement. Plastering was done directly on the blocks without furring or lathing, and the house is perfectly dry.
